TYPICAL REPORT
FURNACE FLOOR TUBE

METALLOGRAPHIC INVESTIGATION OF FURNACE FLOOR TUBE #48 WITH LOCAL WALL THINNING; RECOVERY BOILER

REGISTRATION NUMBER: M013761

DATE: 2005-10-04

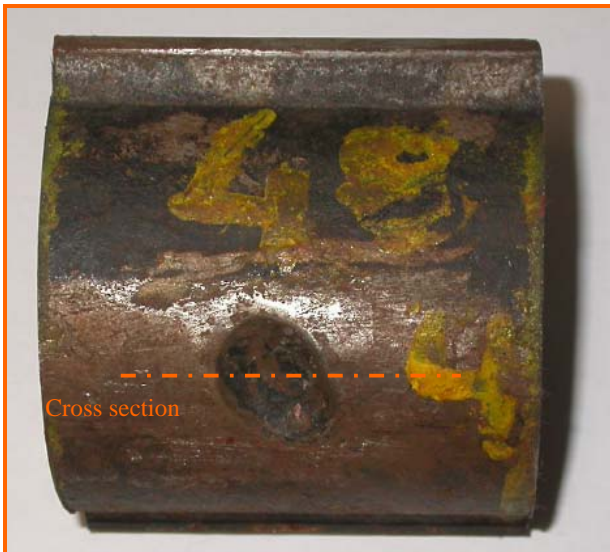
We received one tube sample from furnace floor tube from recovery boiler . The tube sample had a length of about 65 mm with the dimension of \varnothing 63 x 6.4 mm (measured values). See fig.1 and 2 on page 4.

One cross section (parallel to tube axis) was cut out from the area with local thinning, for investigation. For location of the cross section, see fig.1 on page 4. The cross section was prepared and investigated in not etched and etched condition at magnification up to 800 \times . The cross section was etched with nital (etchant A.1 according to SIS-CEN/CR 12361:1996, similar to etchant 74 according to ASTM E 407-99).

Fig.1: Received tube sample with local wall thinning on furnace side. Location of cross section as in fig. above.

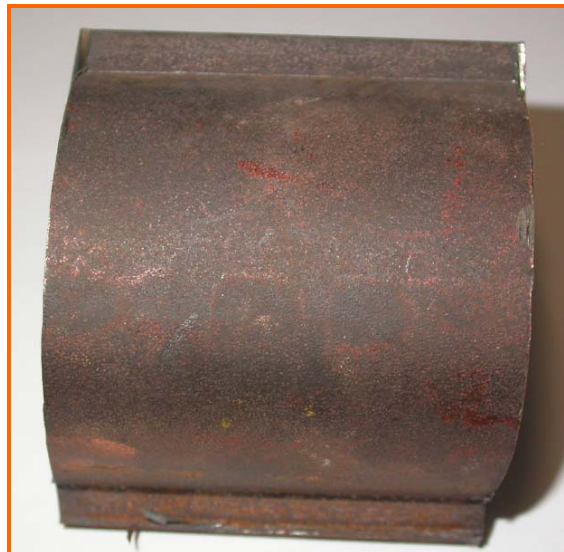
Fig.2: Same tube sample seen from insulation side.

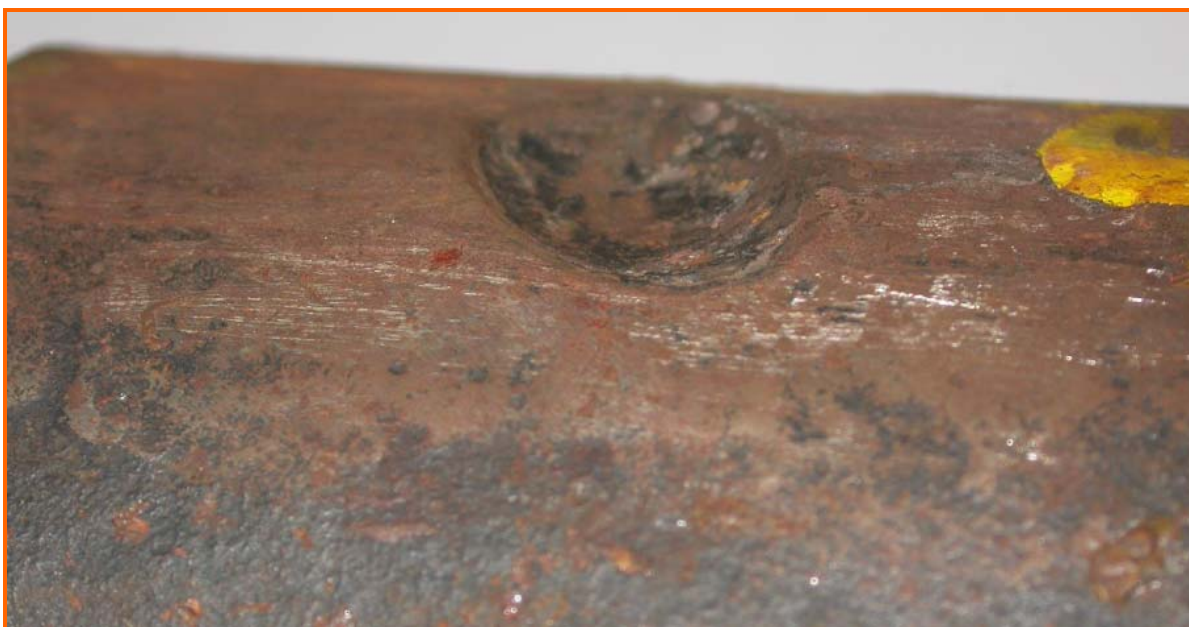
On gas-side towards furnace side we observed a limited region with local thinning (with a surface area of about 20×14.5 mm). See fig.3 on page 4.

Fig.3: Close-up view of area with local wall thinning.

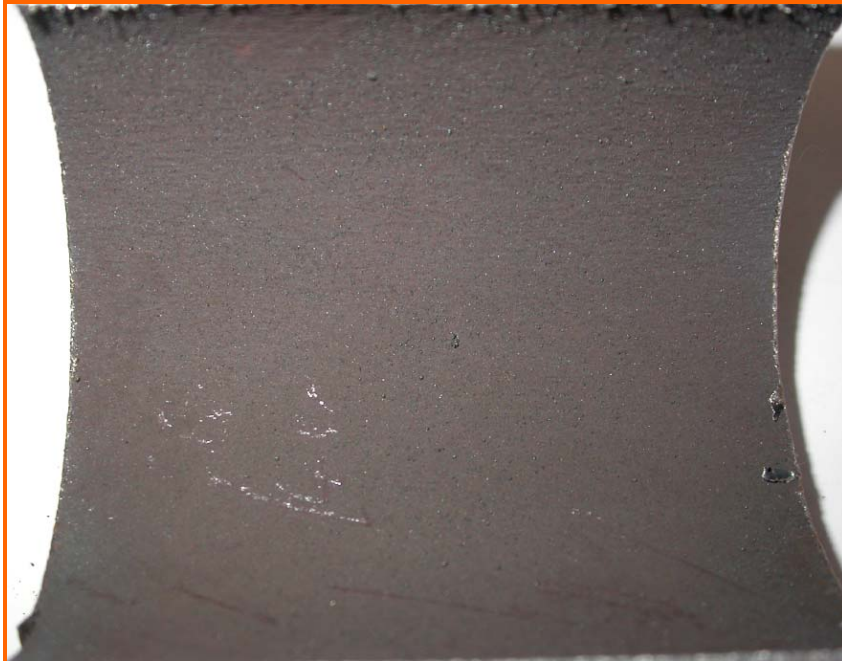
Waterside surface on both furnace side and insulation side was covered by a thin layer of dark brown-coloured deposit/oxide. See fig.4 and 5 on page 5.

Fig.4: Waterside surface, towards furnace side.

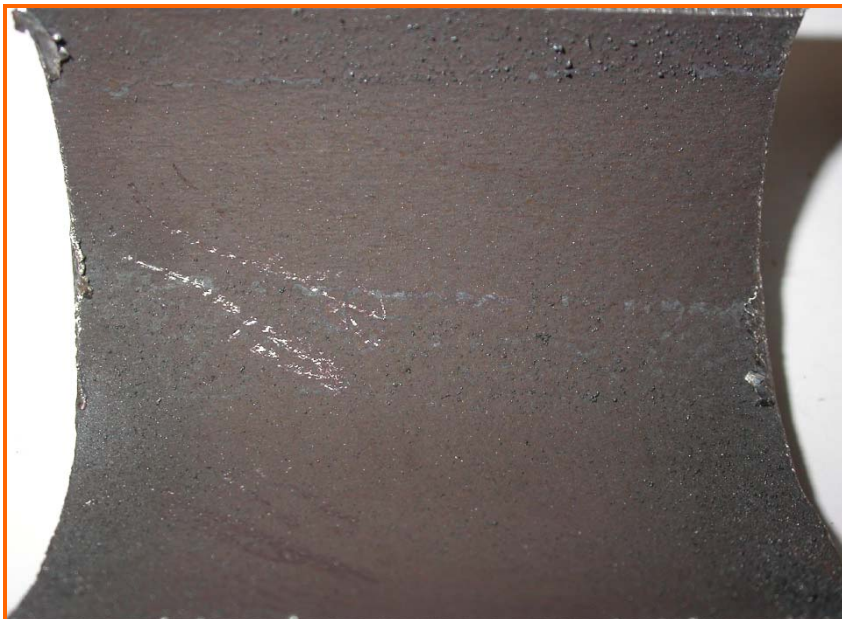
Fig.5: Waterside surface, towards insulation side.

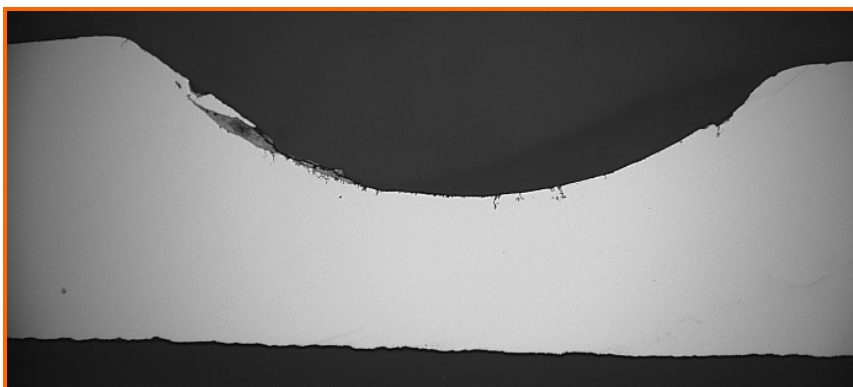
Wall thinning We observed an area with local wall thinning. The minimum wall thickness, in area with local thinning, was measured to 3.2 mm. See fig.6 on page 6.

The wall thinning was calculated to 3.2 mm (which is equal to a 50 % reduction of the wall thickness).

Fig.6: Cross section. Local wall thinning. Minimum wall thickness was measured to 3.2 mm. Not etched. 7 \times .

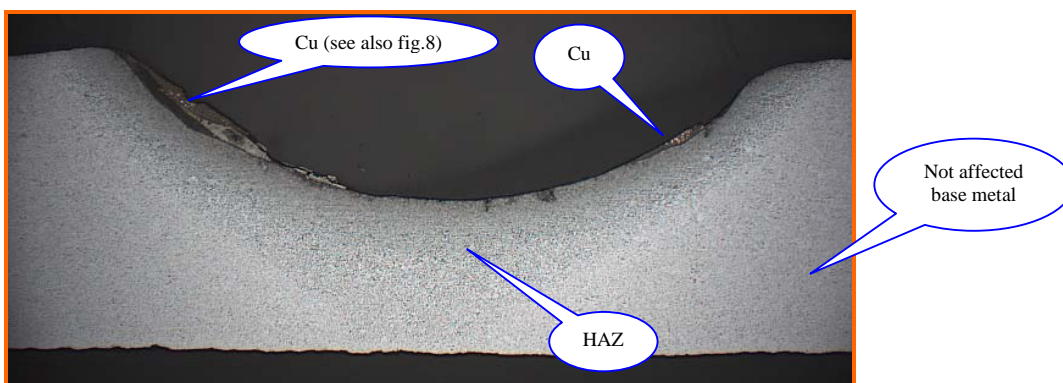
At wall thinning: The structure showed a heat-affected zone (HAZ). See fig.7 on page 6.

We observed large amount of copper inclusions in the zone with different structure. In some areas we observed copper with intergranular extension in the heat affected zone (not the melted zone), indicating copper penetration. See fig.7 to 14 on page 6 to 9. Spectral analysis (x-ray spectra) established that the inclusions consisted of copper.

Fig.7: Same area as in fig.6, in etched condition. We observed a heat affected zone (HAZ) in the area where we observed local wall thinning. We observed occurrence of copper (Cu) towards gas-side. Nital. 7 \times .

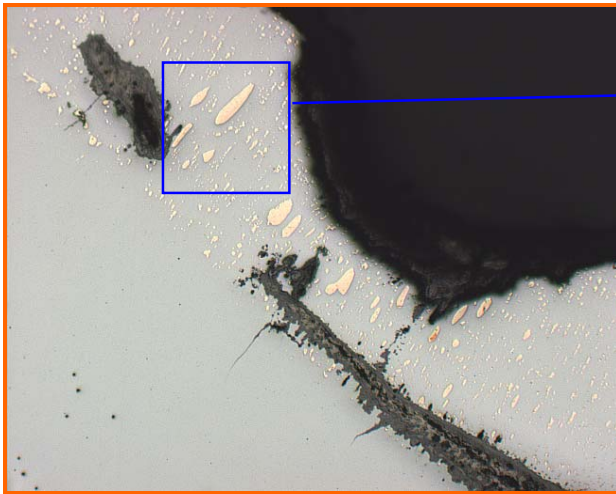
Fig.8: Cross section, towards surface in area with wall thinning. High concentration of copper (Cu). Not etched. 100 \times .

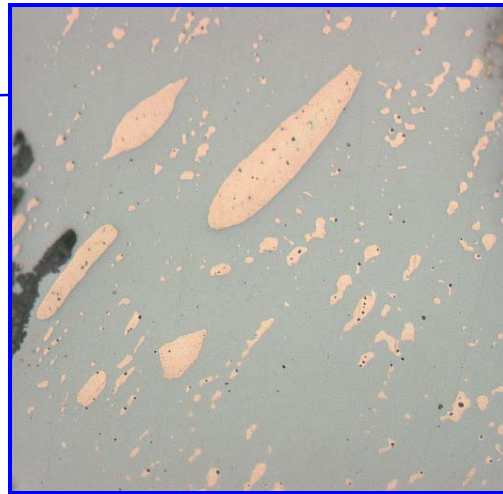
Fig.9: Area with copper (inclusions) at higher magnification. Not etched. 400 \times .

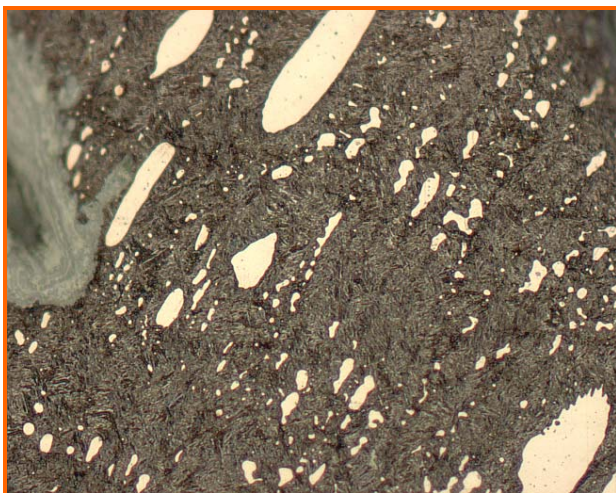
Towards gas-side, in area with wall thinning, we observed a zone with different structure (structural change), probably because part of the tube towards gas-side had been melted. The structure in that zone had not been established, but the hardness indicates a hardening structure. See fig.10 on page 7.

Hardness test (HV10), according to SS-EN ISO 6507-1, had been made in three (3) areas. 1) In the zone enriched with copper and with a hardening structure (melted zone) in area with wall thinning. 2) In heat-affected zone (HAZ) in area with wall thinning. 3) In base metal in area with limited wall thinning.

1.	481 HV
2.	257 HV
3.	145 HV

Fig.10: Same area as in fig.9, in etched condition. The structure consisted of a hardening structure (the hardness of the structure was measured to 481 HV). Nital. 400 \times .

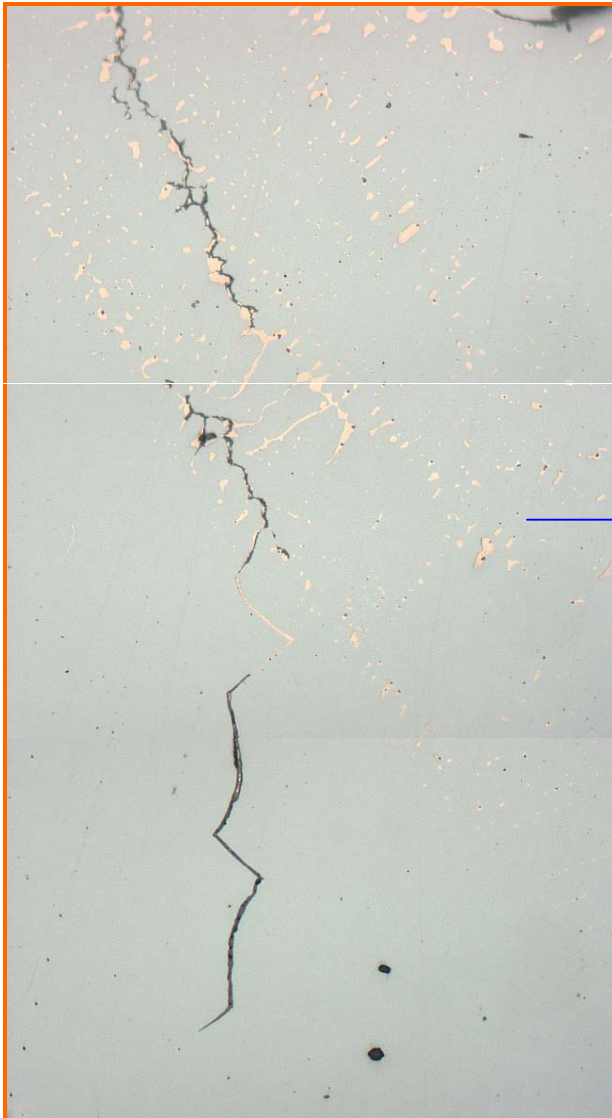
Fig.11 ¹⁾: Cracks (filled with oxides and copper). Not etched. 400×.
The cracks were mainly concentrated to areas with copper (inclusions).

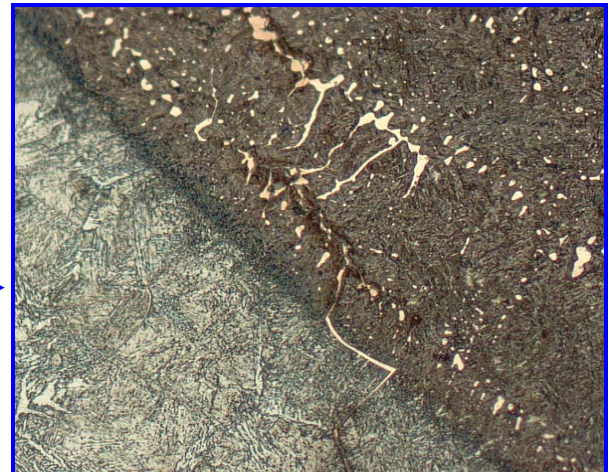
Fig.12: Part of area shown in fig.11, in etched condition.
Nital. 400×.

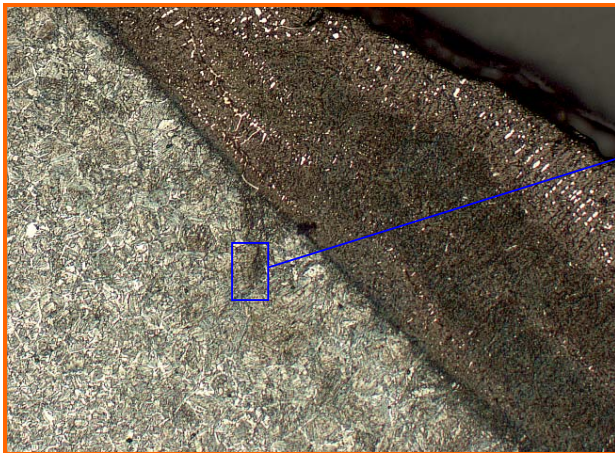
Fig.13: In area with wall thinning, gas-side. Nital. 100×.

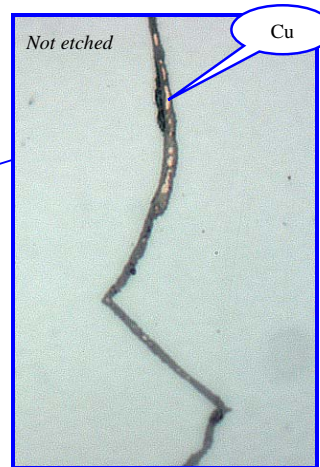
Fig.14: Part of crack (filled with oxide and copper). 800×.

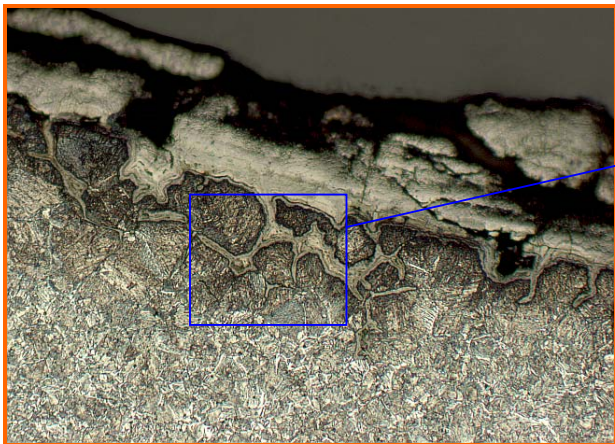
Corrosion	We observed microstructural oriented corrosion (considered to be mainly intergranular) towards gas-side in area with wall thinning. See fig.15 and 16 on page 9. Spectral analysis (x-ray spectra) established presence of sulphur in the corrosion products.
Pit(-s)	Only superficial pits could be observed, with a depth up to 20 µm.
Oxides	Waterside surface was covered by a thin layer of protective oxide. The oxide layer had a thickness of about 5-10 µm. See fig.18 on page 9.

Fig.15: In area with wall thinning, gas-side. Nital. 100×.

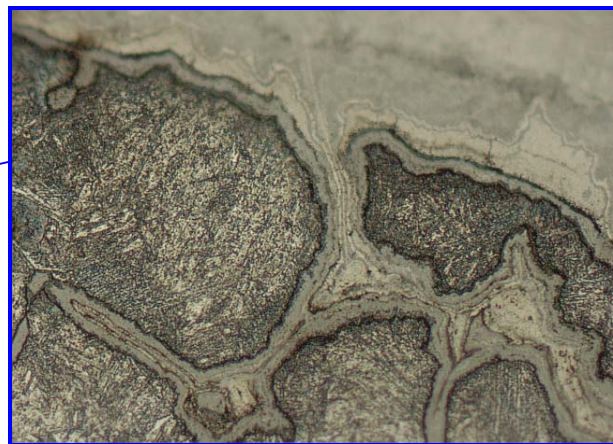
Fig.16: Part of area shown in fig.15, at higher magnification. Nital. 400×.

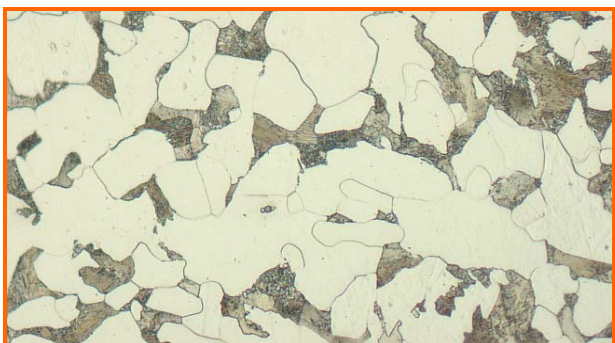
In area with limited wall thinning: The structure consisted of fine lamellae pearlite in a matrix of ferrite, without remarks. See fig.17 on page 9.

Fig.17: Base metal of ferrite and pearlite. Nital. 400×.

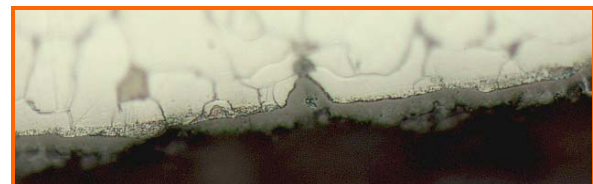
Fig.18: Towards waterside surface. Nital. 400×.
