TYPICAL REPORT
PRIMARY SUPERHEATER TUBE

INVESTIGATION REPORT:

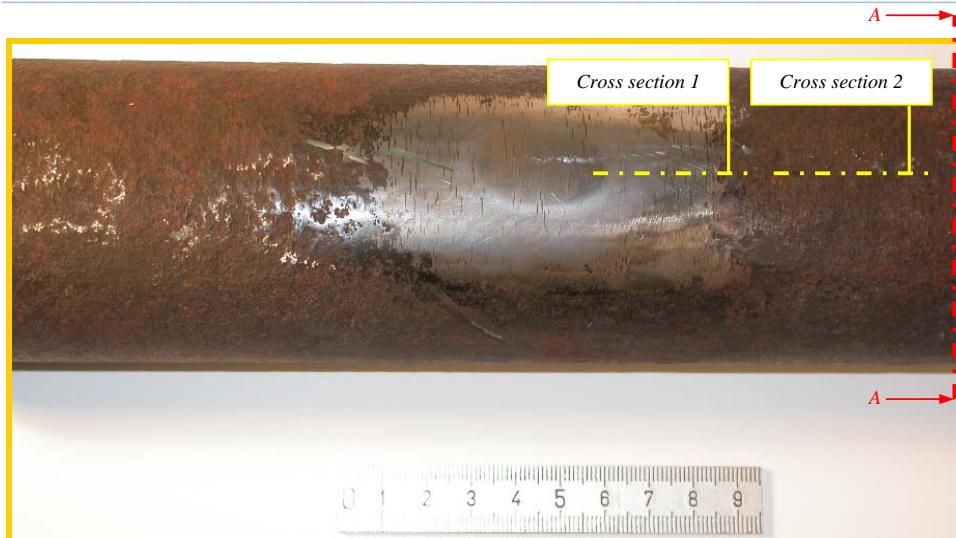
Fig.1: Tube no.1 towards soot-blower side. Part of the tube was ground and polished (due to replica testing at site). Transversal linear indications was observed in this area. Location of cross section 1, 2 and A-A as in fig. above.

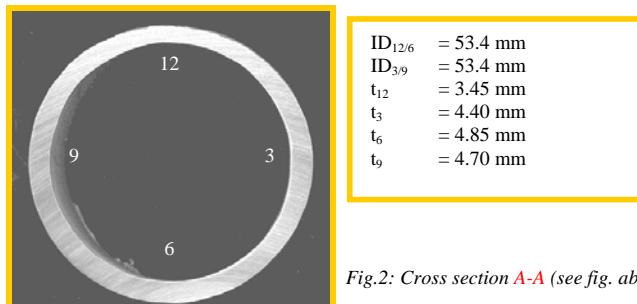
Fig.2: Cross section A-A (see fig. above), for dimension survey. Measurements as in table above.

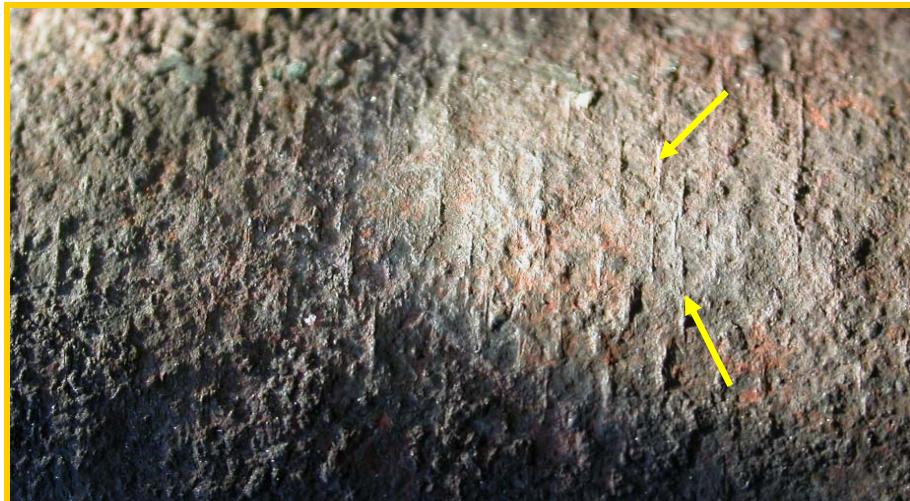
Fig.6: Gas-side towards soot-blower side. We observed transversal linear "elevations" of the surface (in the oxide/deposit layer). The amount, spacing and width of the "elevations" was similar to the linear indications that we observed in the ground and polished area.

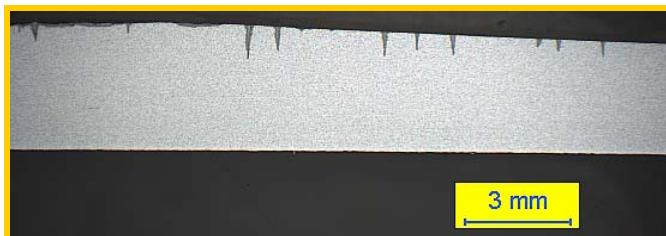
Fig.7: Cross section 1 (cut out from ground and polished area). Several wedge-like cracks, starting from outside/gas-side, could be observed. The cracks were filled with oxides/corrosion products. Etched with nital.

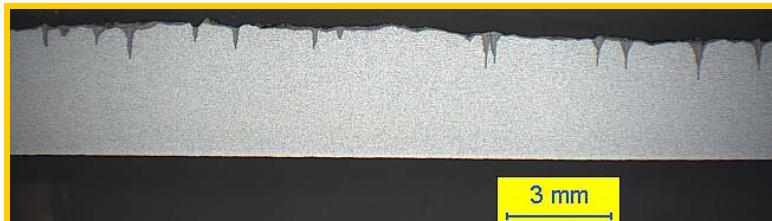
Fig.8: Cross section 2. Several cracks, with depth up to 1.07 mm. Wall thickness was measured to about 3.4 mm. Etched with nital.

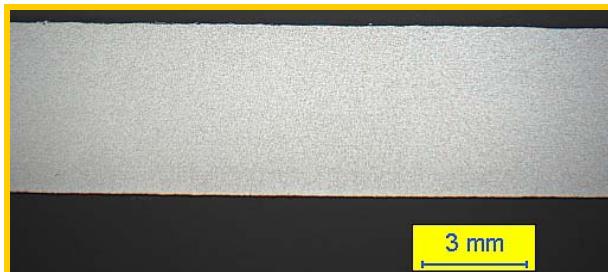
Fig.9: Cross section 3. No cracks could be observed. Wall thickness was measured to about 4.8 mm. Etched with nital.

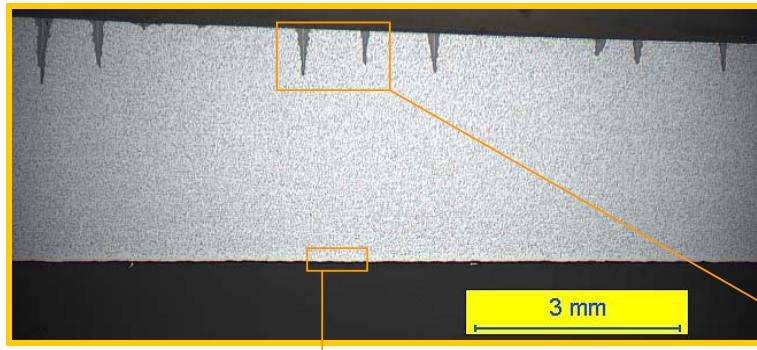
Fig.10: Cross section 1. Same macro as in fig.7 at higher magnification. Several cracks, filled with oxides/corrosion products, initiated from gas-side. The cracks were wedge-like with a direction perpendicular to the tube surface.

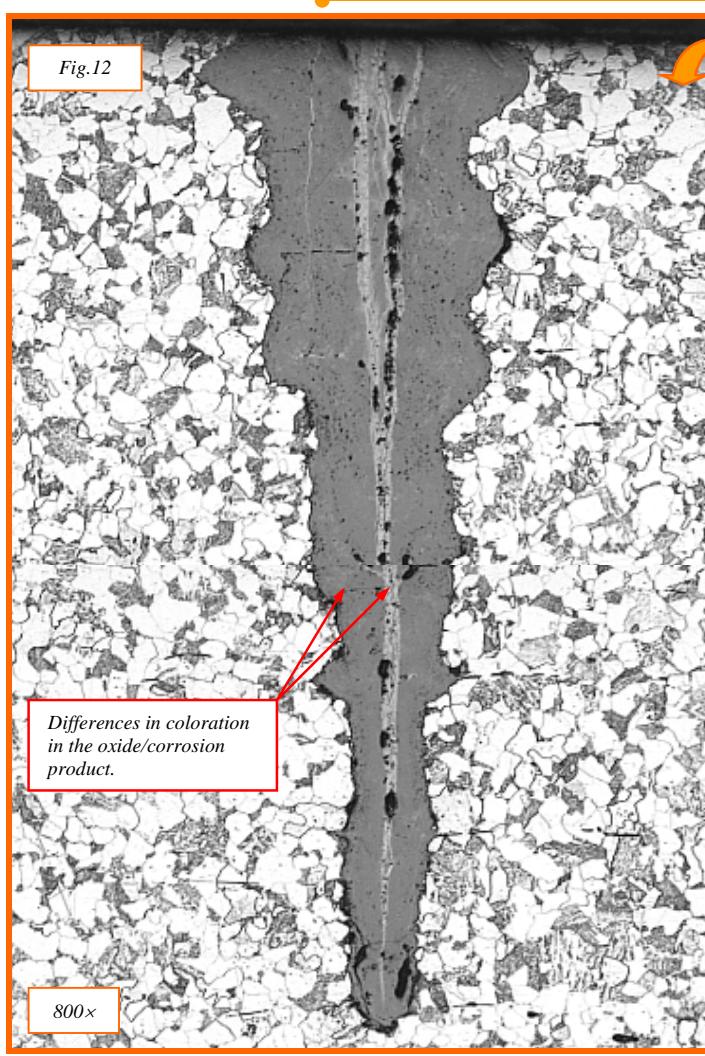
Differences in coloration
in the oxide/corrosion
product.

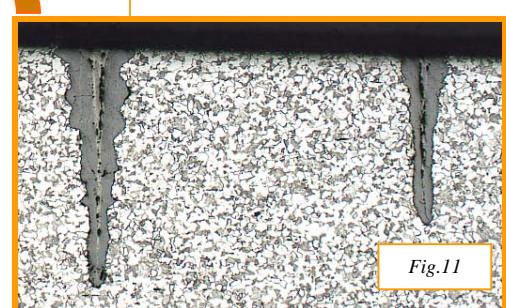
Fig.11: Cracks at higher magnification. The cracks were filled with oxides/corrosion products. Magnification: 50x.

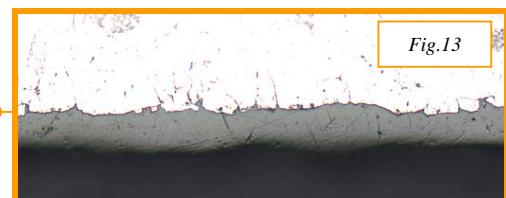
Fig.13: Towards steam-side. The surface was covered by a protective oxide with a thickness of about 10 - 15 µm. 400x.

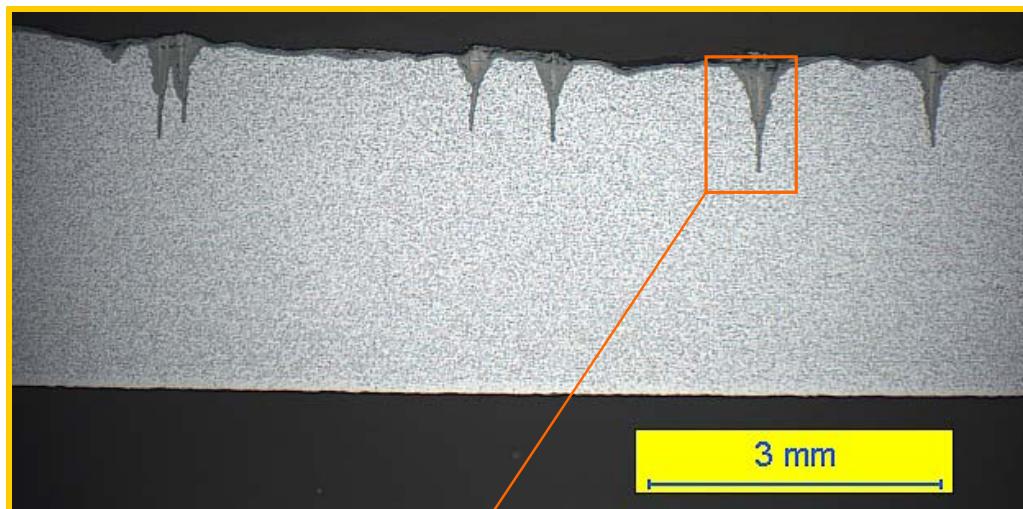
Fig.14: Same macro as in fig.8, at higher magnification.
The cracks were filled with oxides/corrosion products.

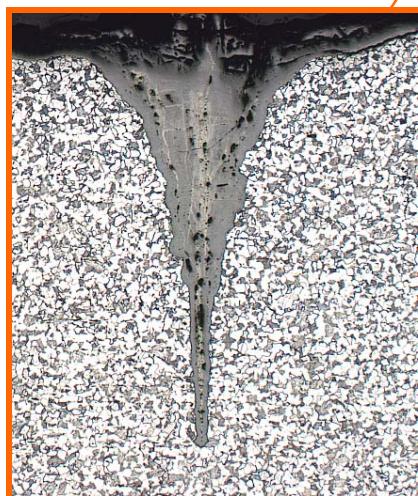
Fig.15: Wedge-shaped crack, filled with oxides/corrosion
products. Nital. 50x.

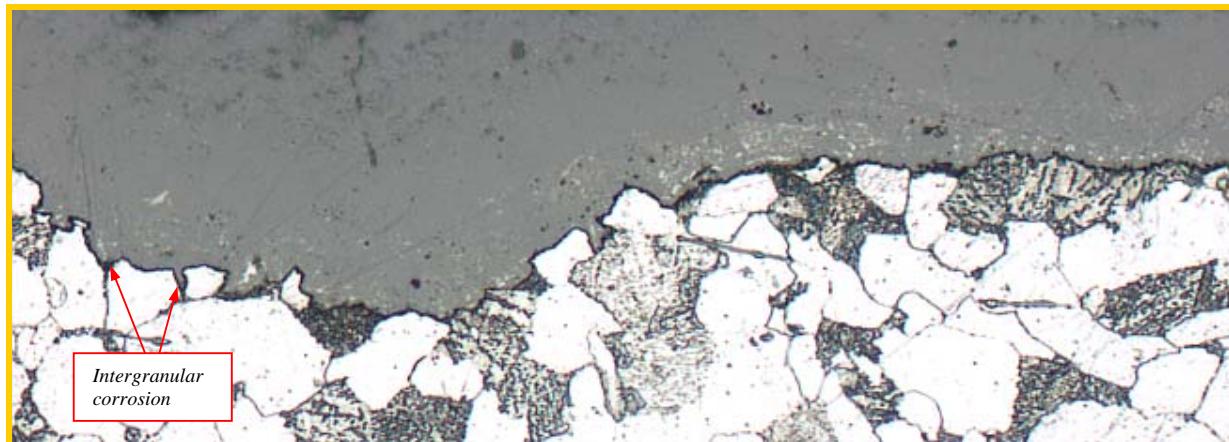
Fig.20: Towards tube surface, on gas-side. Some intergranular corrosion could be observed. Nital. 800×

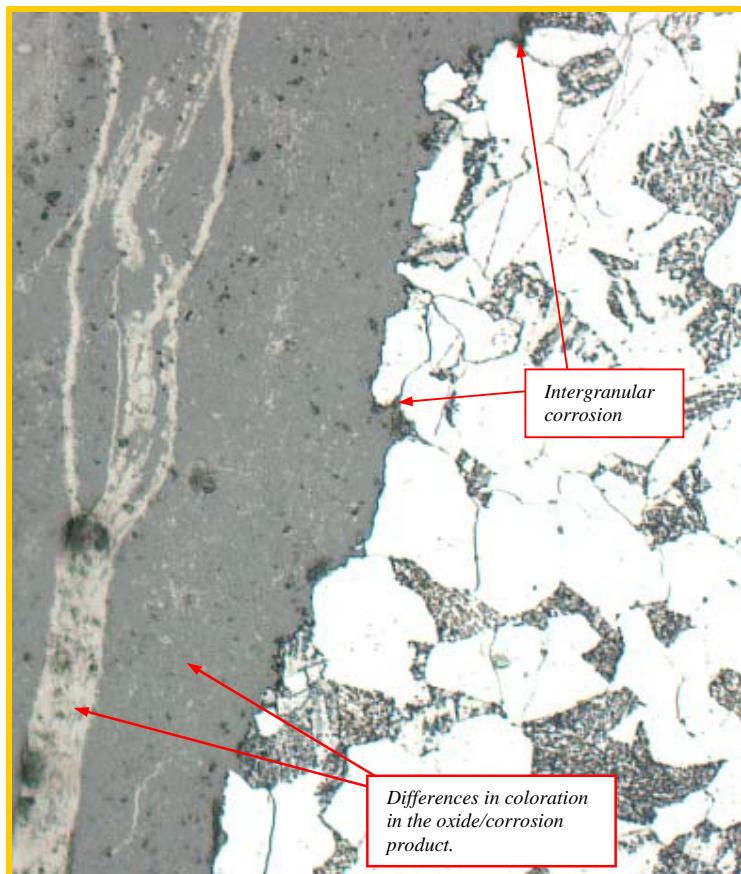
Fig.21: Towards one "crack surface". Similar intergranular corrosion as we observed towards tube surface. Nital. 800×

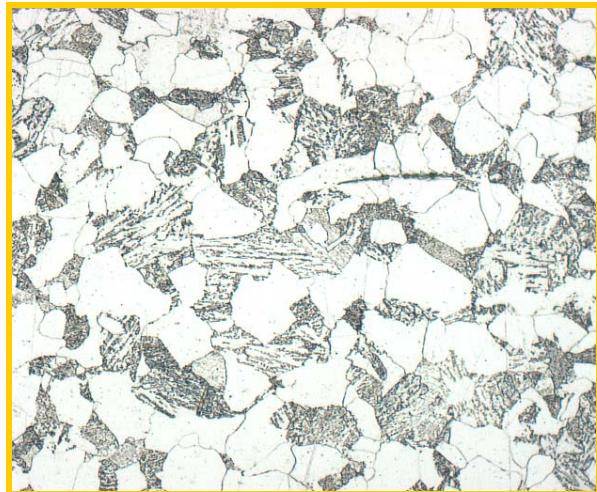
Fig.22: Base metal. Nearly normal perlite in a matrix of ferrite. Some spheroidized carbides could be observed in the perlite. Nital. 400x.

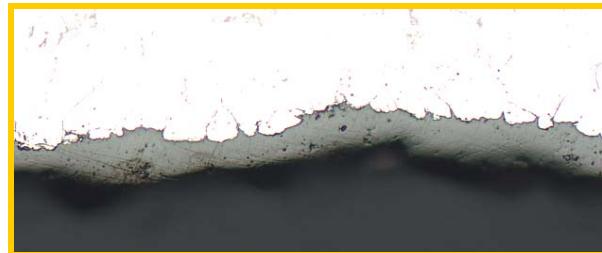
Fig.23: Towards steam-side. The surface was covered by a protective oxide with a thickness of about 10 - 17 µm. 400x.

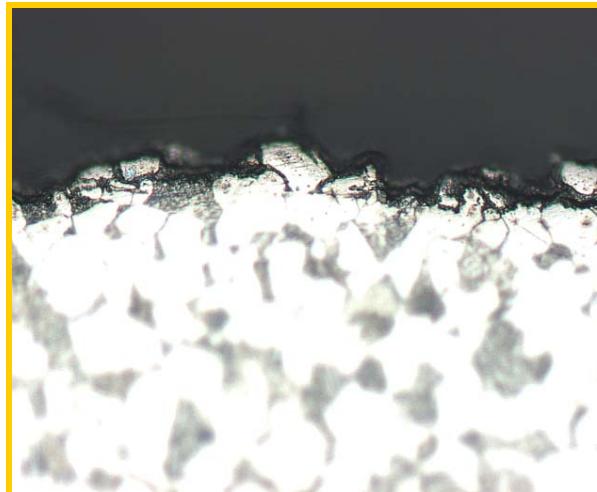
Fig.24: Towards tube surface on gas-side. Some intergranular corrosion. Nital. 400x.

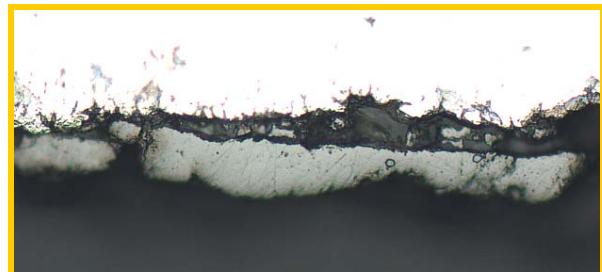
Fig.25: Towards steam-side. The surface was covered by an oxide, detached from the surface, with a thickness of up to 20 µm. 400x.

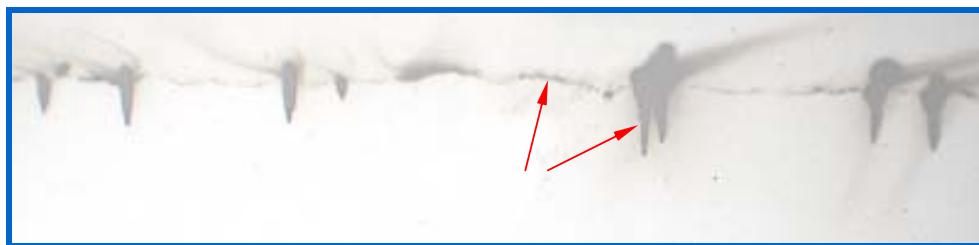
Fig.27: Macro photo of photographic paper after Baumann test of cross section 2. We observed occurrence of sulphur on tube surface towards gas-side and within in the cracks (see arrows).

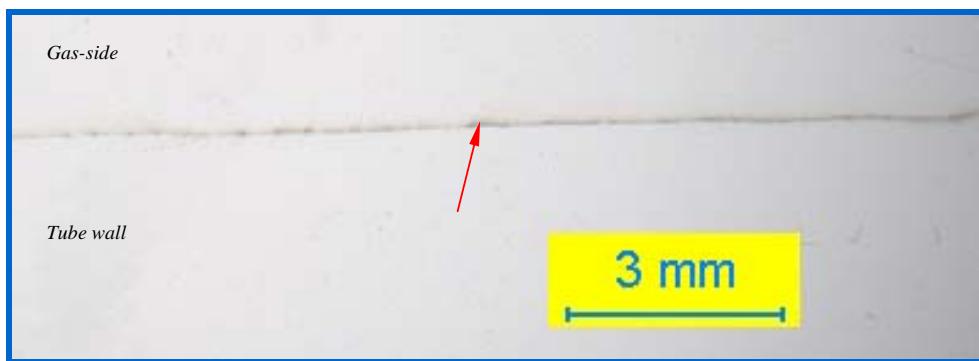
Fig.28: Macro photo of photographic paper after Baumann test of cross section 3. We observed occurrence of sulphur on tube surface towards gas-side (see arrow).
